DEBRIS FLOW DISASTER AT UBUYAZAWA AZUMI MATSUMOTO CITY NAGANO PREFECTURE

Hidehiko MURAOⁱ⁾, Toshiya FURUYAMAⁱⁱ⁾, Toru NOZAKAⁱ⁾, Hiroyuki KOBAYASHIⁱ⁾

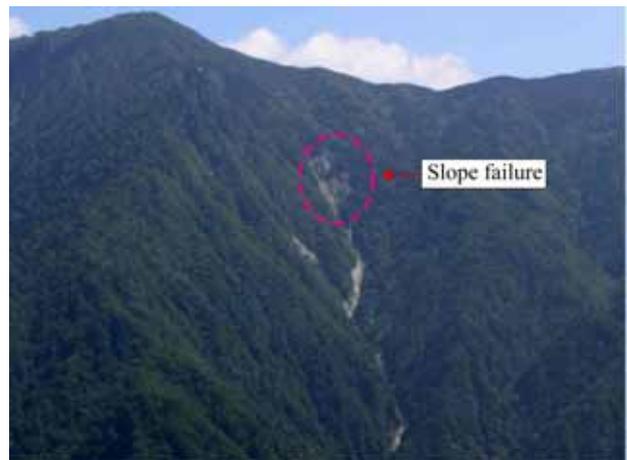
Fig.6 Desolation of Ubuyazawa

Ubuyazawa has very steep stream; an inclination of 1/1.4 at headwaters and 1/5.6 at its downstream. Although no records had been kept, the debris flow happened on 2008 and there are still great amount of sedimentation of outflow debris at the riverbed and around its junction to Azusa River. As it shows in Fig.6, there are lots of slope failures that supply debris at the upstream. As it shows in Fig.4, a lot of slope failures which supply debris exist, and there are great amount of sedimentation in the river bed including boulders, which has been supplied by slope failure, in river bed. Although knick point of topography, there is no buffer zone from headwaters and Ubuyazawa bridge. Therefore debris flow that has happened at the upper stream catches sediments and get to the prefecture road as it grows the volume.

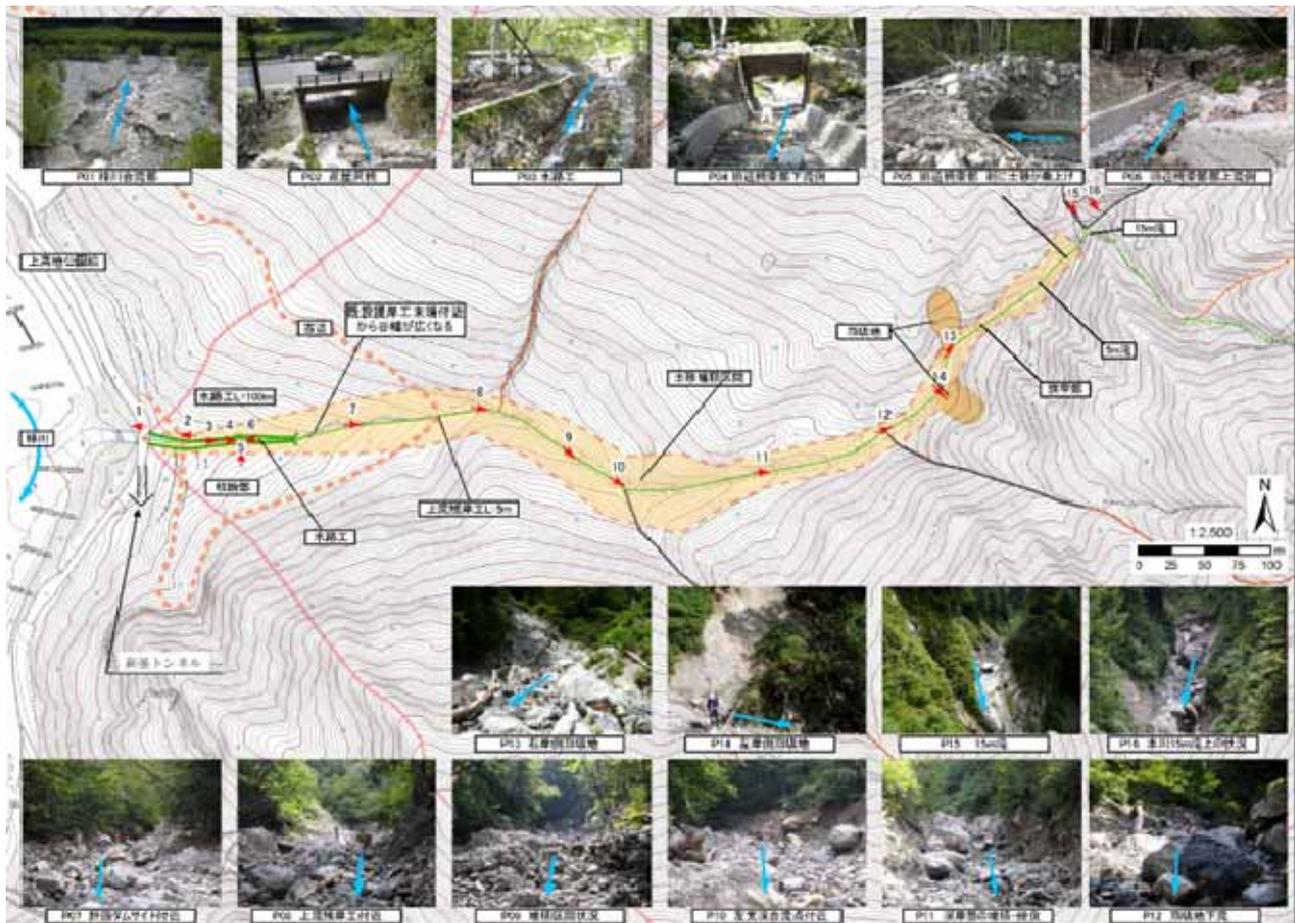
Fig.4 Result of investigation around catchment basin before debris flow happens (2008)

Table.1 shows various factors of catchment basin of Ubuyazawa, Fig.4 shows the results of survey of catchment basin that carried out before the debris flow happened. Fig.5 shows longitudinal slope of river bed of Ubuyazawa.

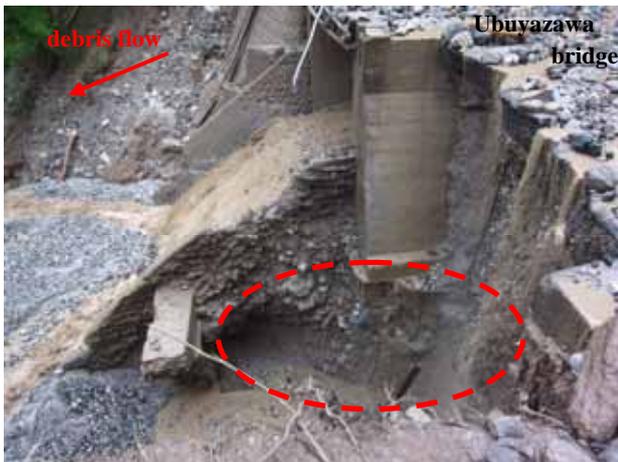
Fig.8 back of abutment and foundation

Around Ubuyazawa bridge, back of abutment on the left bank and foundation were washed away in the debris flow; as it shows in fig.8. Slab of bridge grider on the mountain side is worn away and boulder with over 3m in the major axis blocked cross-sectional area of under bridge, as it shows in fig.9.

- Debris flow deposits in Kama tunnel include boulders with 1m in the major axis, rock fraction, coarse fraction and fine fraction as shown in Fig.11.
- Scour happened on the back of Ubuyazawa bridge by outflow, shown in Fig.8.

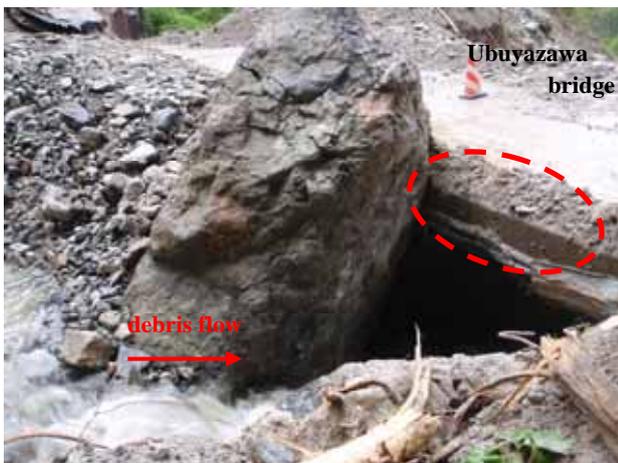
Fig.9 boulder reduced the cross-sectional area of river

- Slab of bridge girder on the mountain side is worn away and handrails were destroyed by the debris flow flow down.
- As it shows in Fig.9, debris flow include boulders with more than 3-2m in the major axis.

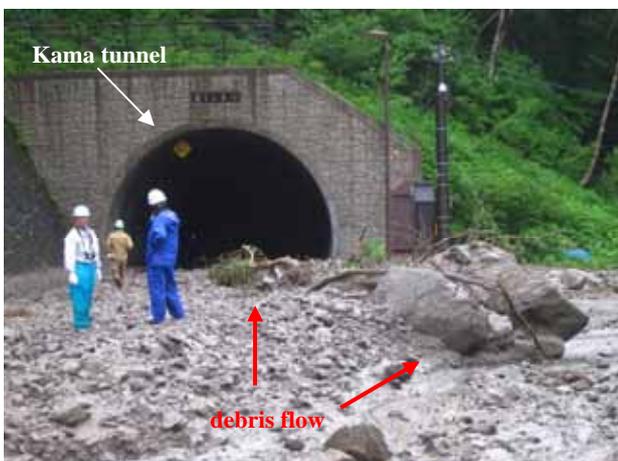
Fig.10 Trace of debris flow flew down Kama Tunnel

The debris flow, which has overflow and changed its flow direction by blockage of areas of under bridge, flew into Kama tunnel as it shows in Fig.10. Fig.11 shows the debris flow deposits in the tunnel. It outflow from the other side of the tunnel as it shows in Fig.12. Debris flow deposits include much rock fraction at about 0.3-0.1m, it can be about 3m in the major axis at the biggest. Fig.13 shows the panoramic view of

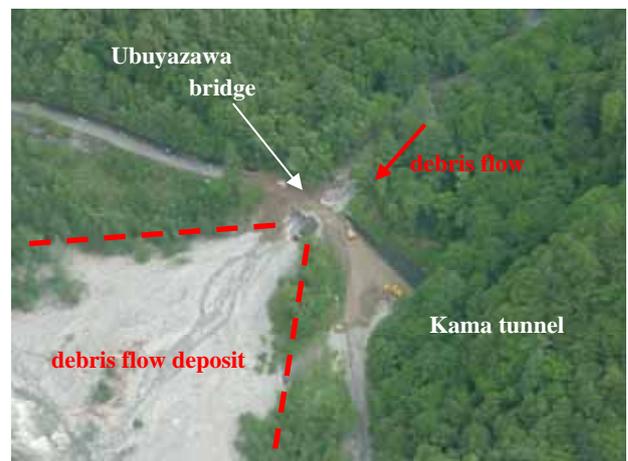
Fig.13 Around Ubuyazawa bridge after the debris flow

neighborhood of Ubuyazawa bridge after the debris flow happened.

- Since there are no banks at the downstream of Ubuyazawa bridge, it gradually expand the width, not suddenly spreading out.
- Debris flow deposits made alluvial fan shape, as shown in Fig.13.

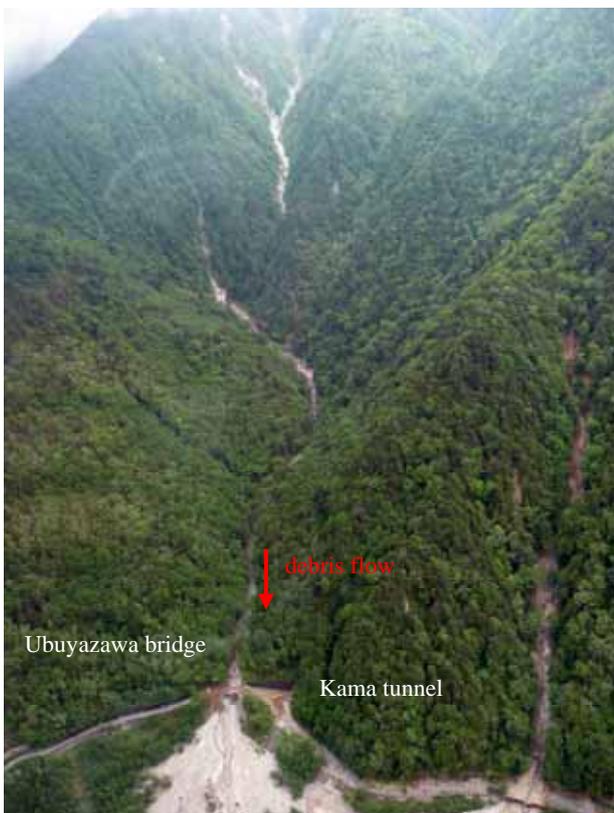
Fig.14 Around Ubuyazawa after the debris flow

- Slope failure which cause forming of natural dam cannot be found from aerial photograph taken on the next day of the debris flow happened (Fig.14) and reconnaissance survey.

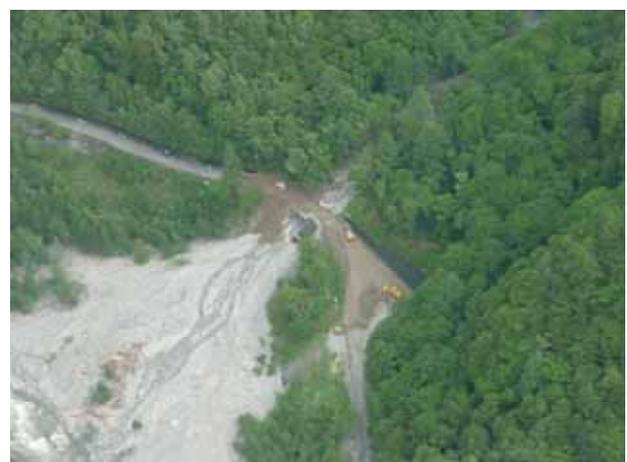
Fig.15 panoramic view of debris flow deposits

Debris flow deposits are accumulated at the downstream of Ubuyazawa bridge. Debris flow tends to form bumps (lobes) of debris blocks with long and thin shaped toward its flow direction. However obvious lobes cannot be found at the sedimentation point in the downstream of Ubuyazawa bridge. Fig.15 shows panoramic view of debris flow deposits that has accumulated in alluvial fan shape.

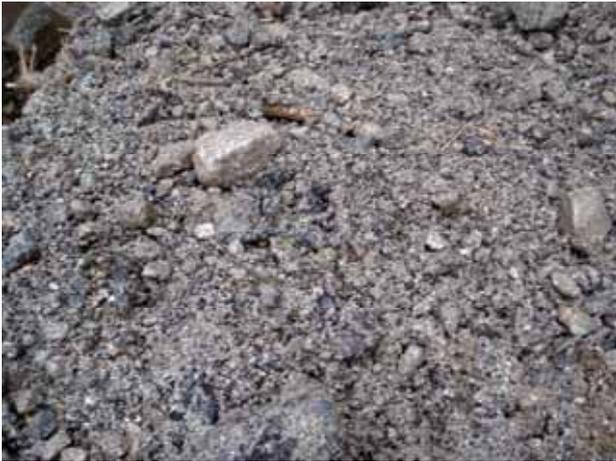
Fig.16 Debris flow deposits

Fig.16 shows debris flow deposits, which include various granule size mainly rock fraction and coarse fraction. Fig.17 shows vegetation along the stream since scratches on the vegetation can be seen, it is sure that debris flow flow down up to about 5m high with increasing that volume.

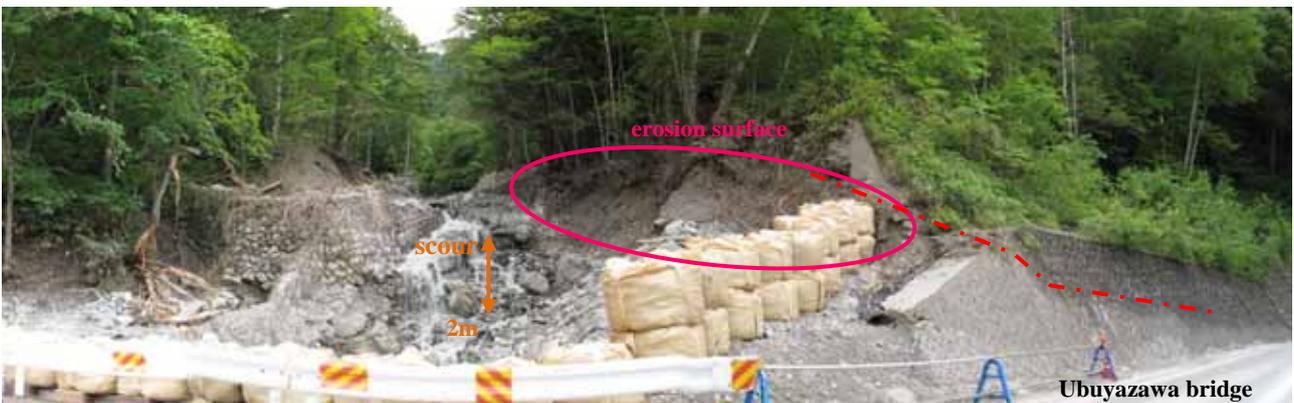
Fig.18 Upper site of Ubuyazawa bridge

Fig.18 shows the situation of flow route at the upstream of Ubuyazawa bridge. Flow route that has maintained by stone masonry was broken by debris flow. Especially, it can be seen that riverbed was scoured about 2m in depth on top of breaking stone masonry. By blockage of areas of under bridge and

accumulation of debris flow deposit on the bridge, the flow which has changed its flow direction to Kama tunnel flow down as washing the left bank violently out. Fig.19 shows the situation of 150m upstream of Ubuyazawa bridge. It can be seen that the debris flow flew down as eroding both side of the previous flow route of the retained mason for more than 5m with increasing its volume. It is possible that around 150m upstream of Ubuyazawa bridge was the area that debris was accumulated intermittently, because the area is a knick point and accumulation of boulders. Yet, the boulders which are on the left bank on Fig.19 were not the ones that accumulated by this debris flow.

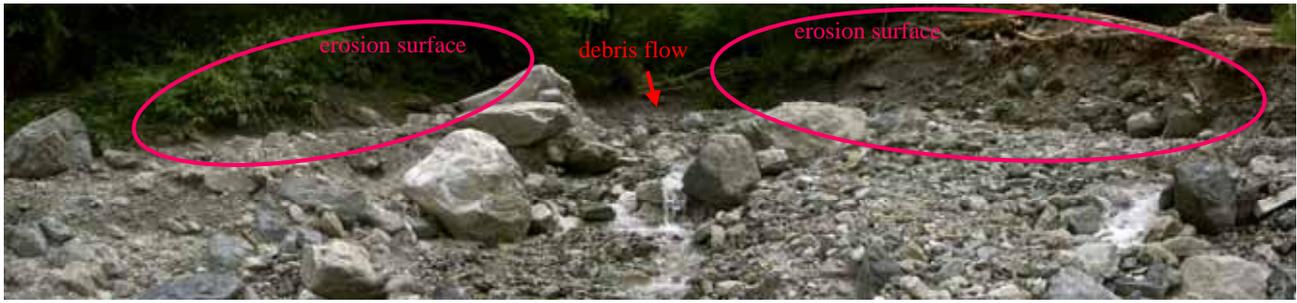
Fig.20 Erosion situation of both bank (400m upstream of the Ubuyazawa bridge)

Fig.20 shows the situation around 400m upstream of Ubuyazawa bridge. It can be seen that the debris flow flew down as eroding both side of the previous flow route for more than 5m with increasing its volume. It is possible that around 400m upstream of Ubuyazawa bridge was also the area that debris was accumulated intermittently, because the area is a knick point and accumulation of boulders.

Therefore, existence of accumulating boulders and relation of knick point almost correspond. These results supported the possibility that around knick point can be a place for debris to intermittently accumulate when debris flow flows down as stated in "MECHANISM OF DEBRIS FLOW BROKE OUT AT UBUYAZAWA", No. v
