DEBRIS FLOW DISASTER AT UBUYAZAWA AZUMI MATSUMOTO CITY NAGANO PREFECTURE

Hidehiko MURAOⁱ⁾, Toshiya FURUYAMAⁱⁱ⁾, Toru NOZAKAⁱ⁾, Hiroyuki KOBAYASHIⁱ⁾

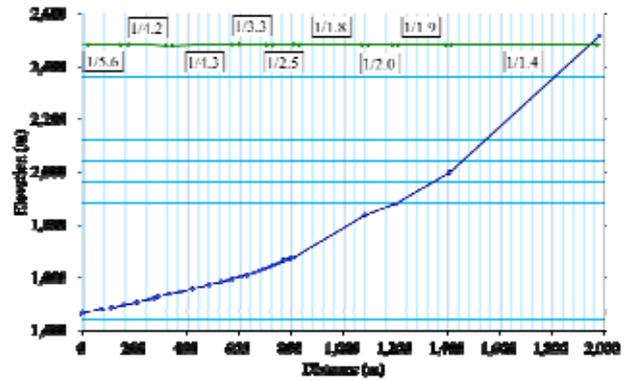
Fig.5 Longitudinal slope of river bed of Ubuyazawa

Table.1 shows various factors of catchment basin of Ubuyazawa, Fig.4 shows the results of survey of catchment basin that carried out before the debris flow happened. Fig.5 shows longitudinal slope of river bed of Ubuyazawa.

Ubuyazawa has very steep stream; an inclination of 1/1.4 at headwaters and 1/5.6 at its downstream. Although no records had been kept, the debris flow happened on 2008 and there are still great amount of sedimentation of outflow debris at the riverbed and around its junction to Azusa River. As it shows in Fig.6, there are lots of slope failures that supply debris at the upstream. As it shows in Fig.4, a lot of slope failures which supply debris exist, and there are great amount of sedimentation in the river bed including boulders, which has been supplied by slope failure, in river bed. Although knick point of topography, there is no buffer zone from headwaters and Ubuyazawa bridge. Therefore debris flow that has happened at the upper stream catches sediments and get to the prefecture road as it grows the volume.

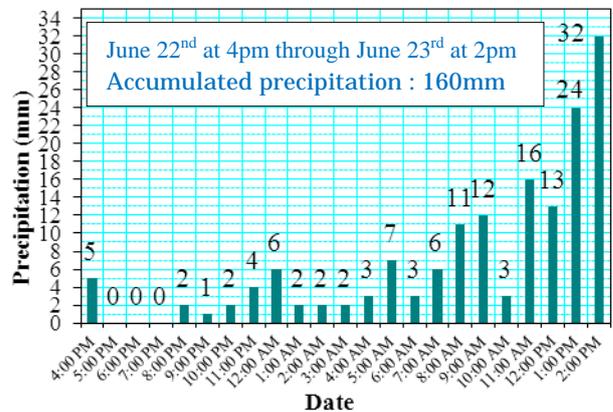
Fig.7 Precipitation of pre-debris flow

Fig.7 shows the precipitation at Mt. Yakedake observation point, before the debris flow happens (June 22nd at 4pm through June 23rd at 2pm). It started raining at about 18hours before the debris flow occurred and accumulated precipitation reached up to 150mm.
